Donald B. Smith Roofing Inc. installs a metal roof system on a stone home
by Krista Reisdorf

Project name: Donald Smith Jr. Estate

Roof system type: Metal and EPDM

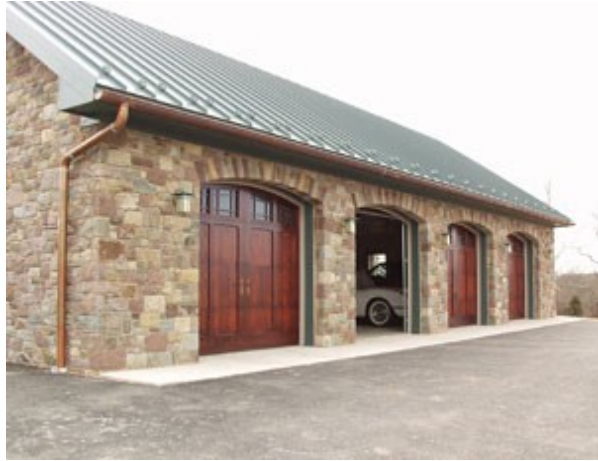
The metal roof system was a 16-inch- (406-mm-) wide PAC-CLAD® 0.032 aluminum Snap Clad™ roof panel from Petersen Aluminum Corp., Elk Grove Village, Ill., in a custom green color. Copper half-round gutters were installed to accent the cornice.

"The roof system consisted of an exposed tongue-and-groove plank ceiling with 3 inches (76 mm) of polyisocyanurate roof insulation and 5/8-of-an-inch- (16-mm-) thick plywood deck material," Doug Smith says. "The plywood was covered with a water barrier in the valley and eaves with two layers of No. 30 roofing felt installed over the main roof area."

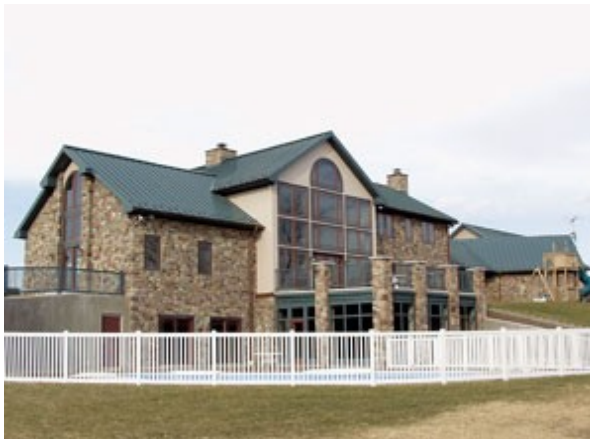
Donald B. Smith Roofing installed an aluminum roof system in a custom green color.

"Flashing any roof system wall detail against a stone wall always is a concern because the mortar joints in stone absorb water," Doug Smith says. "When you have a stone wall or chimney above a roof line, it is important to have reglets and through-wall flashing installed to remove the water from the inner wall cavity before it enters the house. We ask all our general contractors to install a smooth block wall at the roof line then install the reglet and through-wall flashing with weep holes. The masonry workers then will start the stone work above the weep holes to the finished elevations. If water enters the cavity, it runs down to the through-wall flashing and out the weep holes.

"Meeting and reviewing the flashing details with the owner and masonry contractor before installation made the task much easier to accomplish," Doug Smith continues. "Flashing a roof is easy when you are going to a smooth block wall instead of a stone wall at the roof line."
