A piece of the past

Donald B. Smith Roofing Inc. installs a new roof on a historical railroad station

**Project name:** Lincoln Train Station

**Project location:** Gettysburg, Pa.

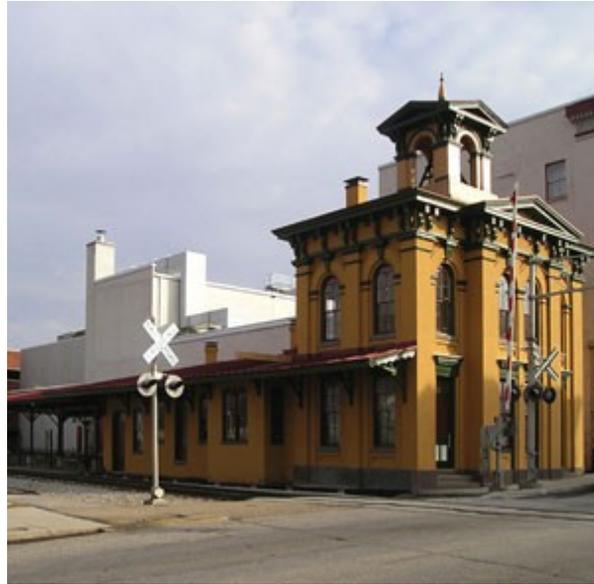
Donald B. Smith Roofing Inc., Hanover, Pa., installed a new roof on a historical railroad station

"On the higher bell tower roof, we installed a custom flat-soldered seam with all panels and hidden gutters formed in our metal shop," Smith says. "The panels were formed from 18-by 24-inch cuts of Follansbee Steel's Terne-Coat stainless steel, which was painted red by the painting subcontractor."

"On the lower peaked roof, we installed a Terne-Coat Follansbee stainless-steel 17-inch-wide double-lock standing-seam roof system with matching half-round gutter and downspouts," he continues. "All metal used was 28-gauge Terne-Coat stainless steel for roof panels, flashings and trims. Painting again was performed by the painting subcontractor."
